THE CALIFORNIA EARTHQUAKE OF APRIL 18, 1906

STATE EARTHQUAKE INVESTIGATION COMMISSION

IN TWO VOLUMES AND ATLAS

ANDREW C. LAWSON, CHAIRMAN

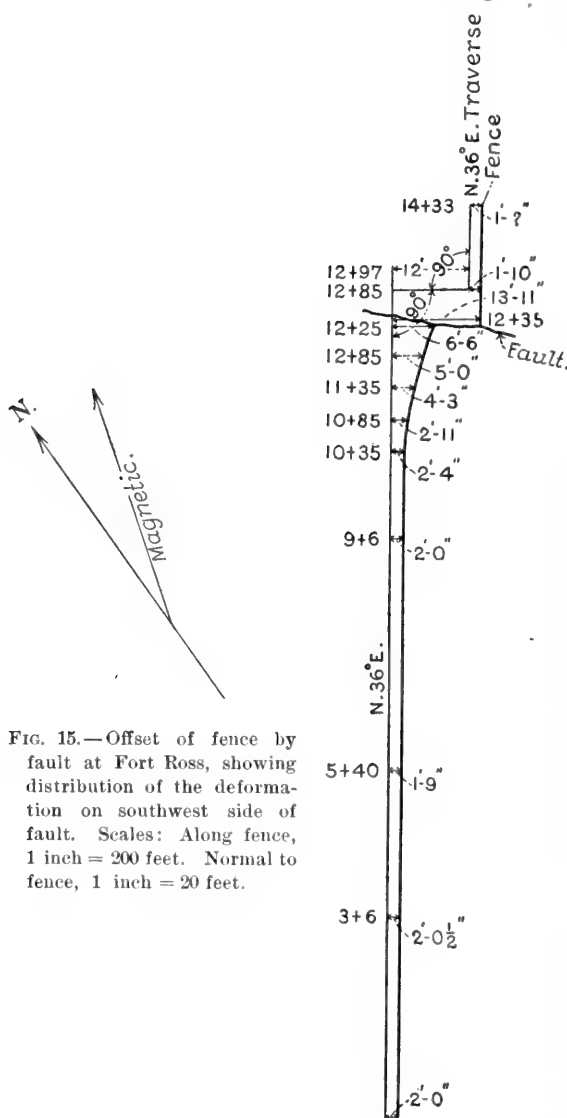
FIG. 15.—Offset of fence by fault at Fort Ross, showing distribution of the deformation on southwest side of fault. Scales: Along fence, 1 inch = 200 feet. Normal to fence, 1 inch = 20 feet.

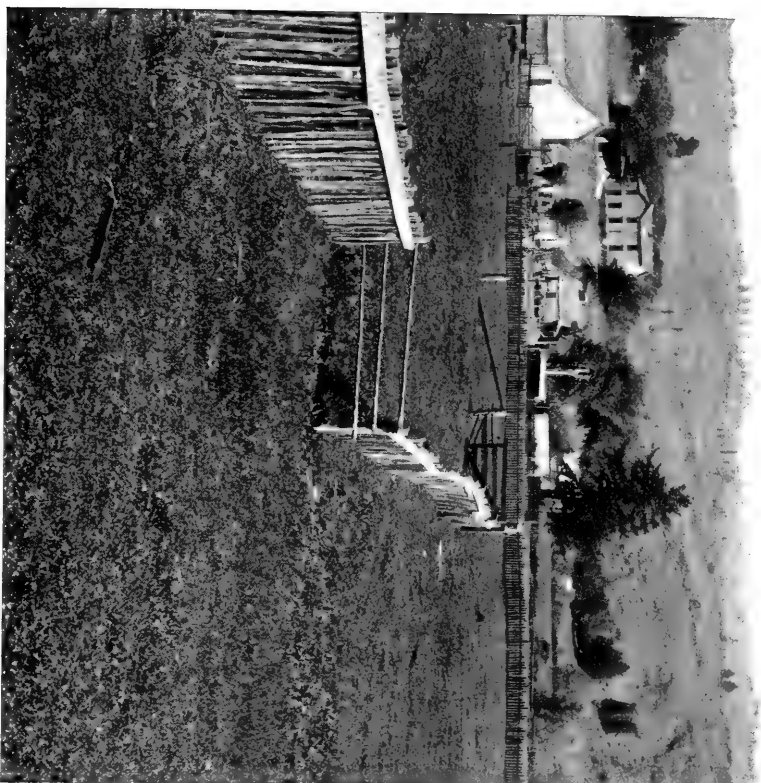
A. Fence offset by fault. Looking northwest. Camera was aimed with straight part of fence beyond the disturbance, to bring out flexure as well as offset of fence. G. K. G.

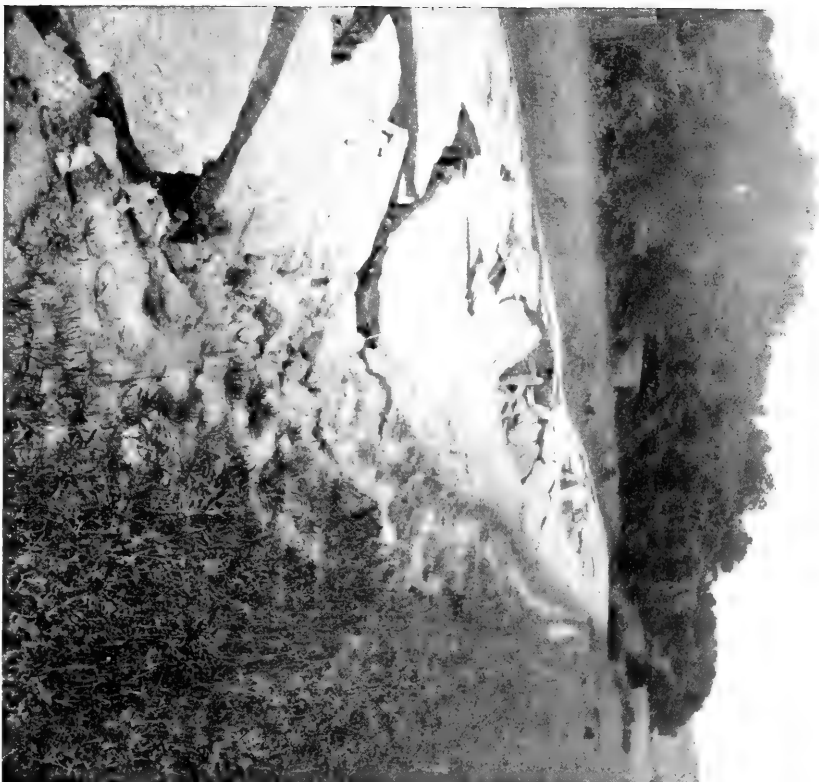
A. Road embankment broken by shaking of soft ground beneath. Southwest of Point Reyes Station and 10 rods from fault-trace. G. K. G.

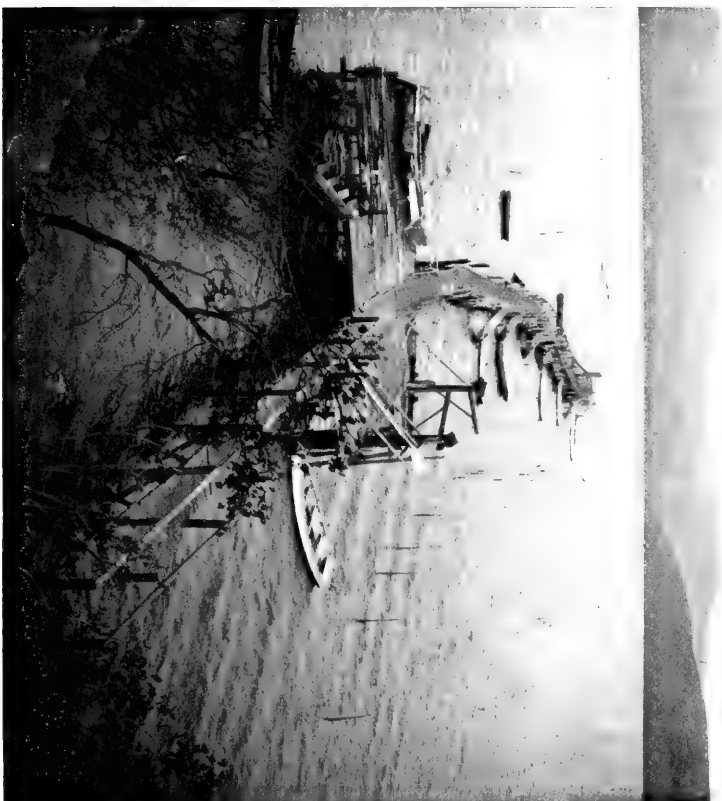
B. Bailey's pier at Inverness. Originally straight; shifted and much broken by earthquake. In subsequent repairs curvature caused by earthquake was retained. G. K. G.

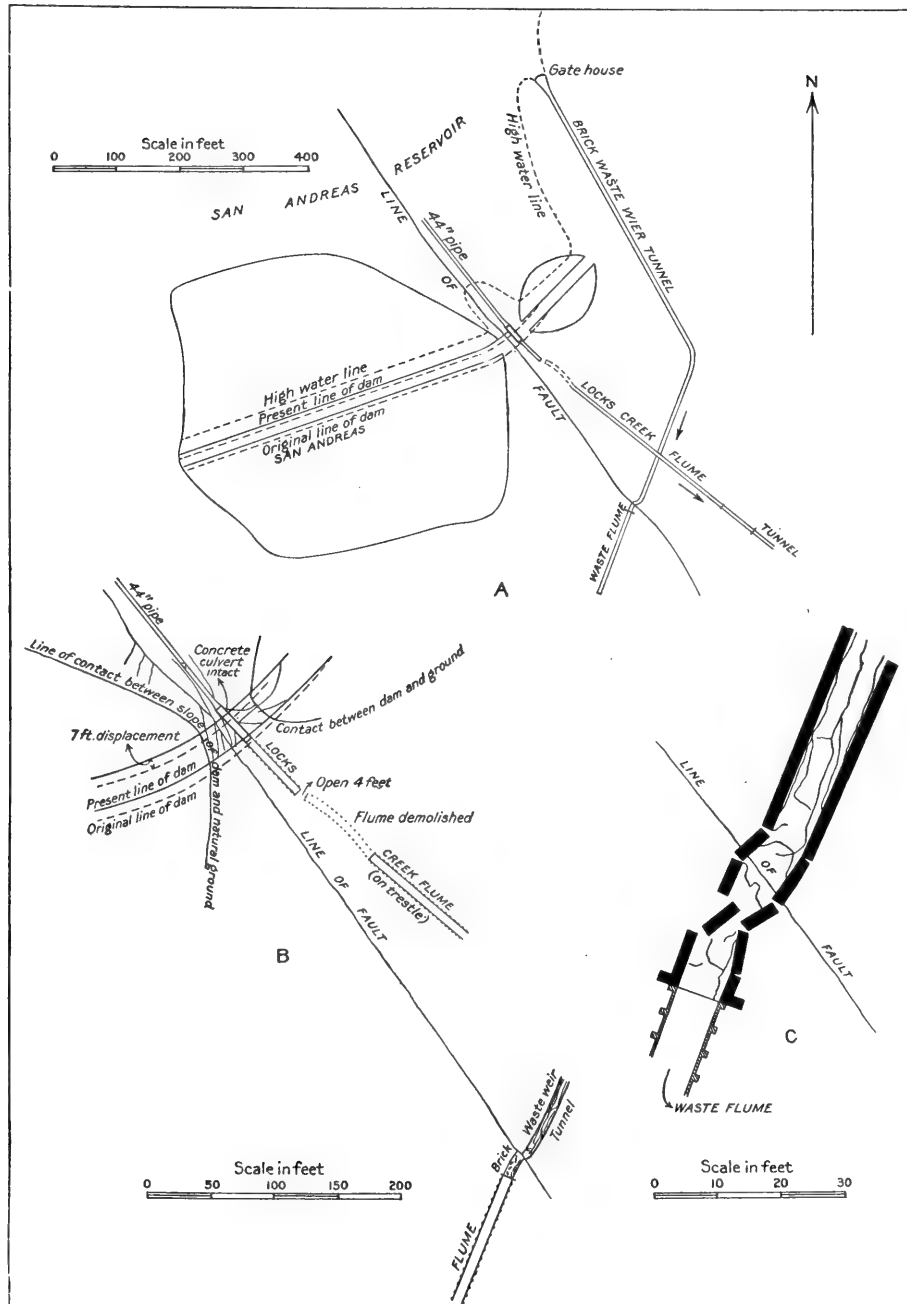
At the San Andreas dam, the fault past thru a rocky knoll which serves as an abutment for the dam on both sides, the embankment being in 2 parts. The rocks were shattered and the road over the dam and the fence paralleling it were offset several feet in the usual direction. The ground here was traversed by several cracks, those on the south-

FIG. 36.— Intersection of San Andreas dam by fault. A. Plan of dam in two parts, with rock between. B. Relation of dam to waste weir tunnel. C. Detail of waste weir tunnel.

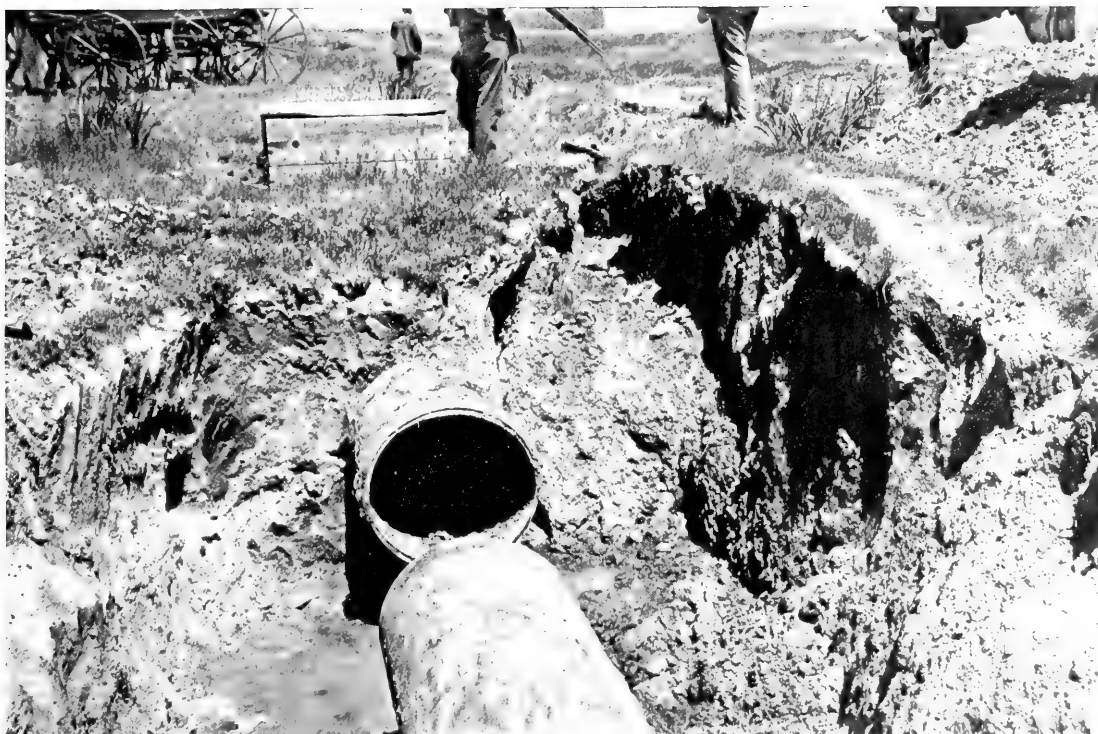
A. Rupture of 30-inch water-pipe by fault. Northwest of San Andreas Lake. A. C. L.

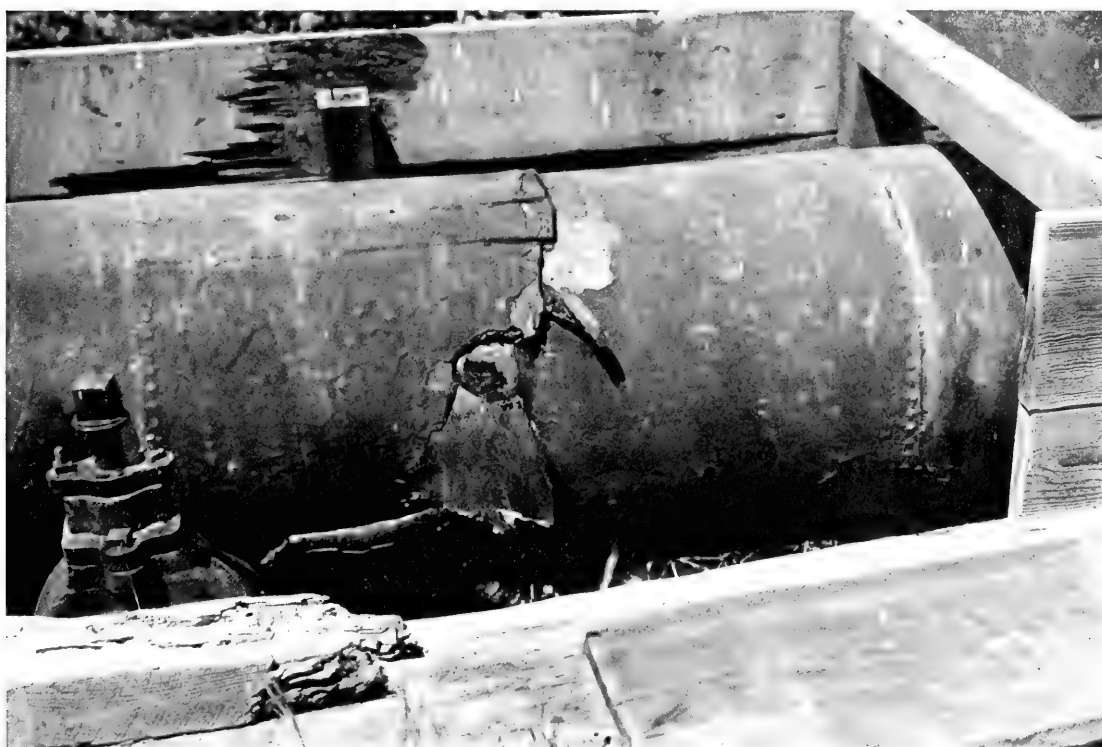
B. Thrust of 30-inch water-pipe by fault, northwest of San Andreas Lake. Amount of telescoping is 58 inches. A. C. L.

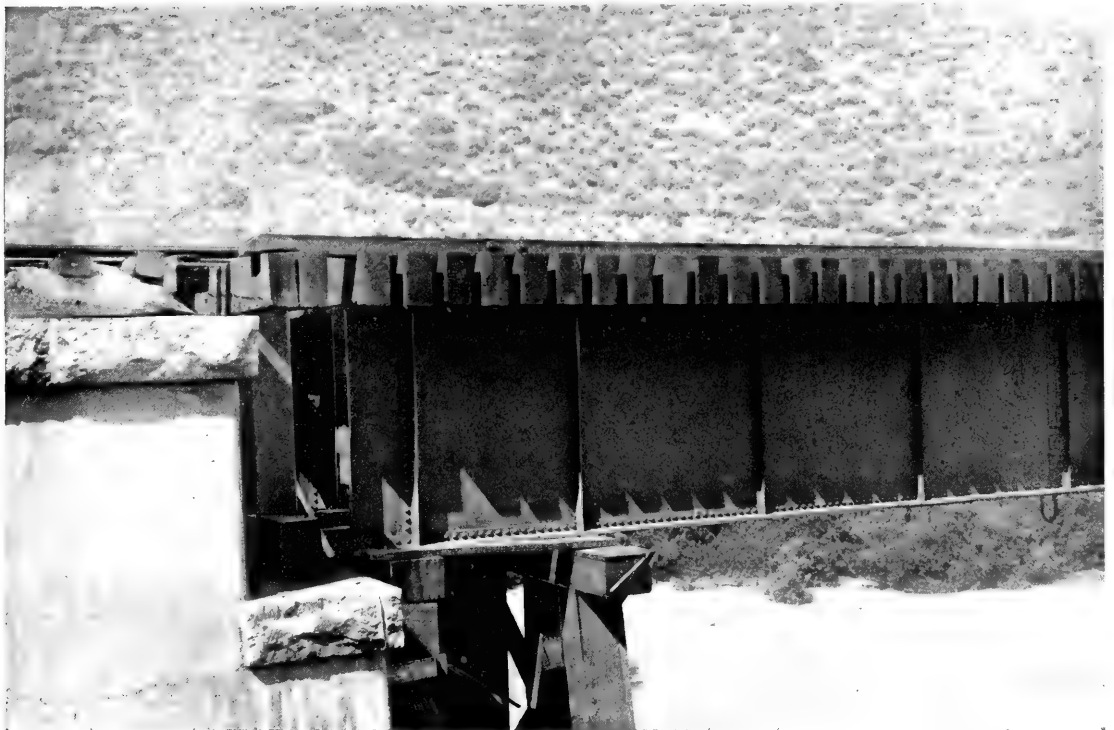
B. Steel bridge over Pajaro River, near Chittenden, dragged from its abutment 3.5 feet. Compare Fig. 43. A. C. L.

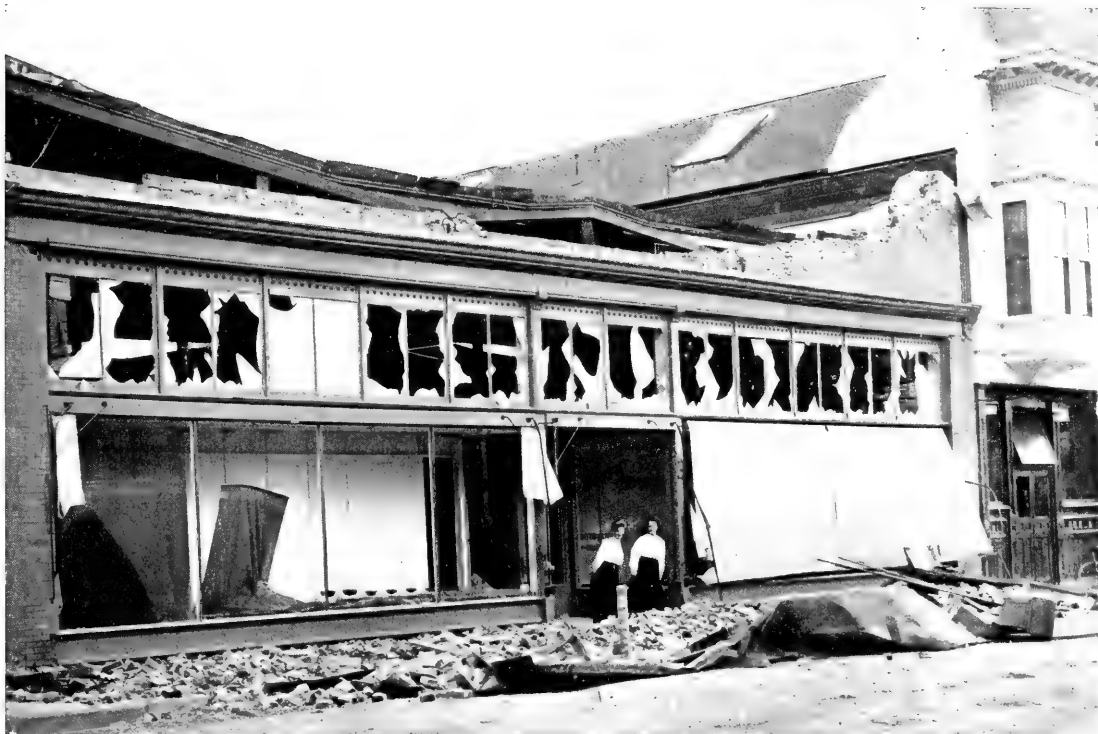
A. Wrecked stores. Ferndale, Humboldt County.

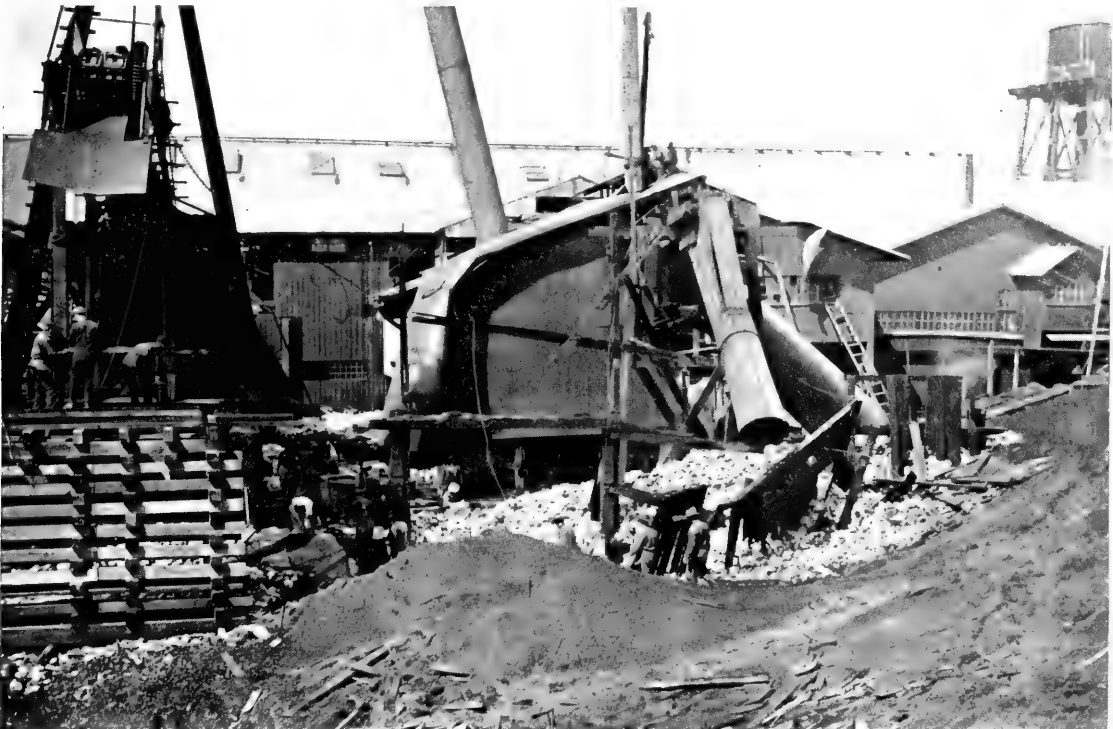
B. U. C. Co.'s mill, Fort Bragg. Smoke stack 5 feet in diameter. Entire structure thrown out of plumb to south, 1 foot in 20 feet.

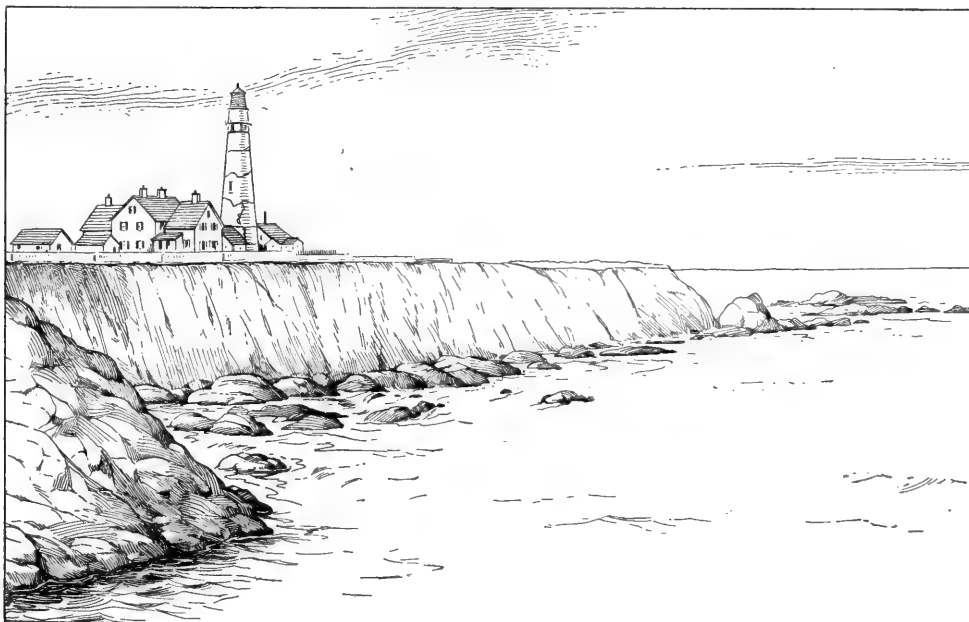
FIG. 49. — Cracks in light-house tower, Point Arena. ;

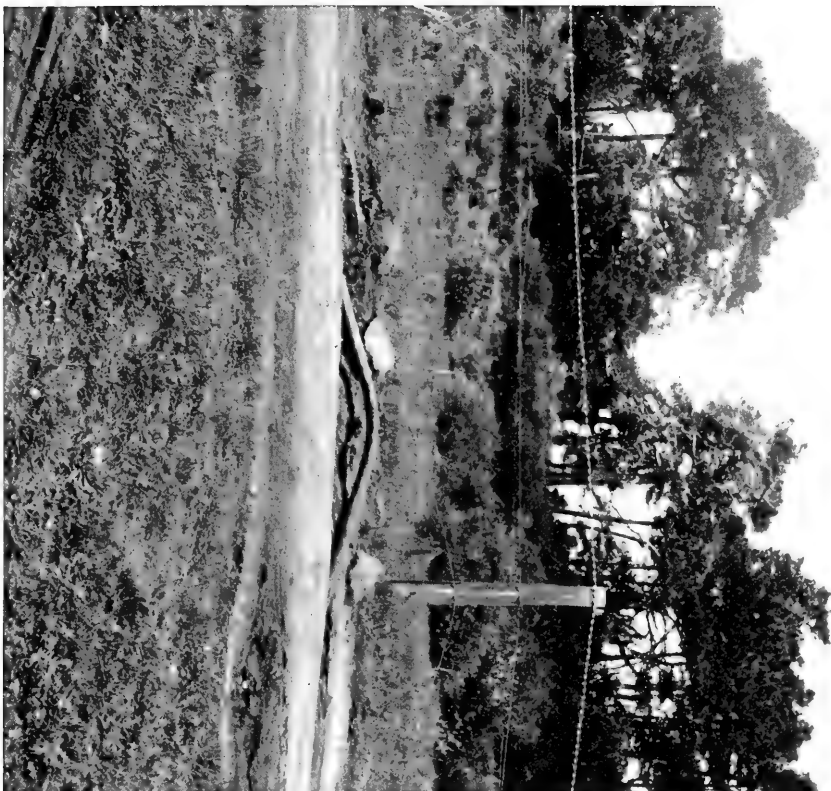
A. Buckled water-pipe, Inverness. G. K. G.

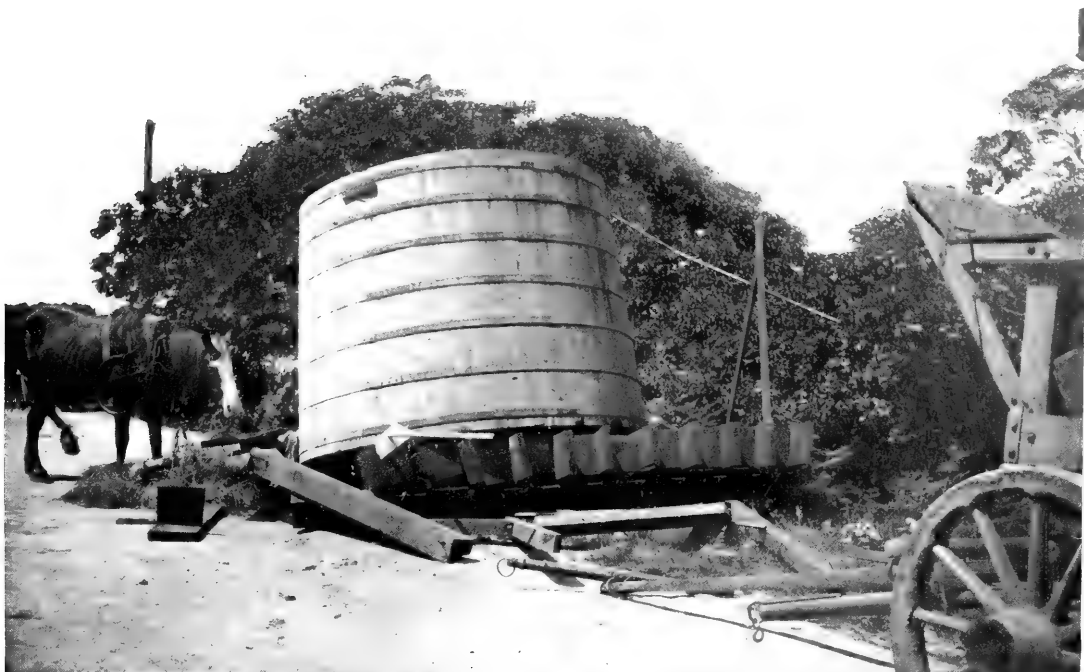
B. Wrecked water-tank near Inverness. G. K. G.

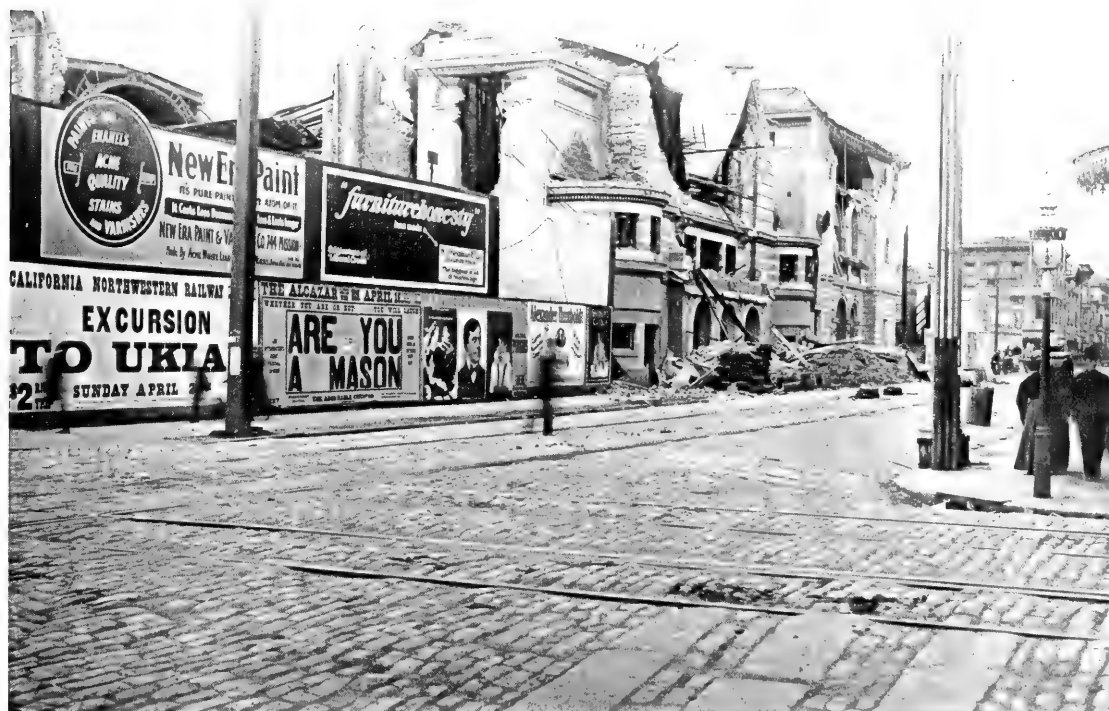
B. Geary Street, between Filmore and Steiner Streets, San Francisco. Buildings of mediocre construction on sand and alluvium of no great depth. A. C. L.

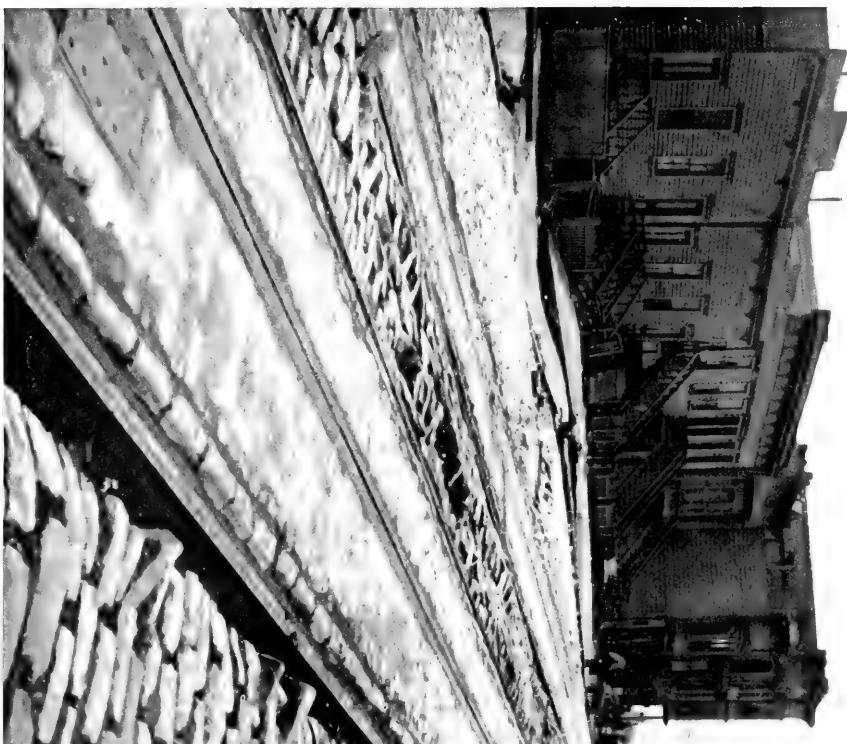
A. Ninth Street, between Bryant and Brannan. Undulation and fissuring of pavement and sidewalks. Houses over-trough have been dropt from their underpinning. G. K. G.

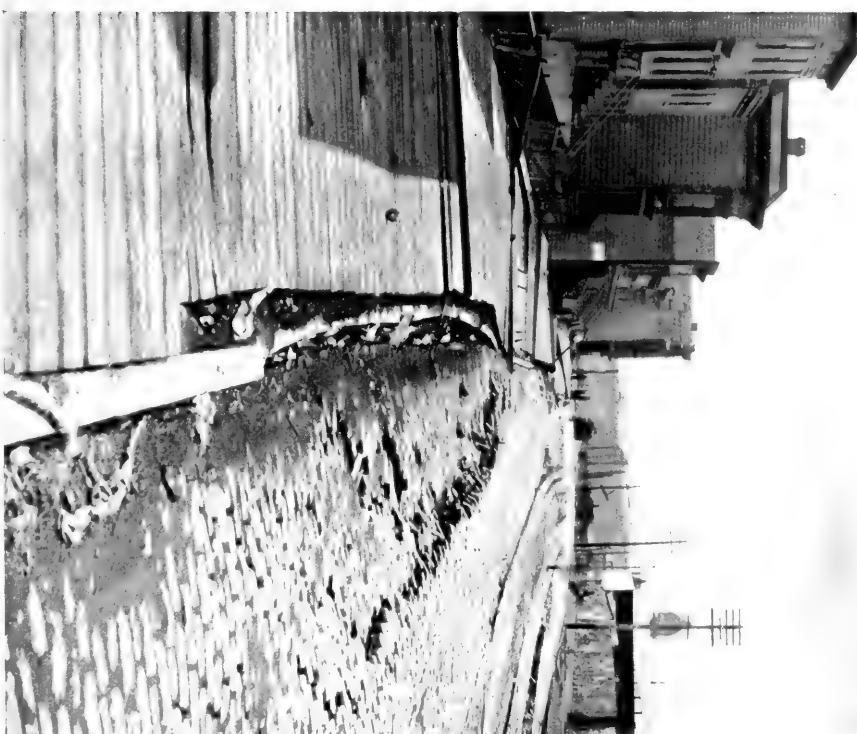
B. Ninth Street, between Bryant and Brannan. Westward lurching of land toward former creek channel where Dore Street now is. G. K. G.

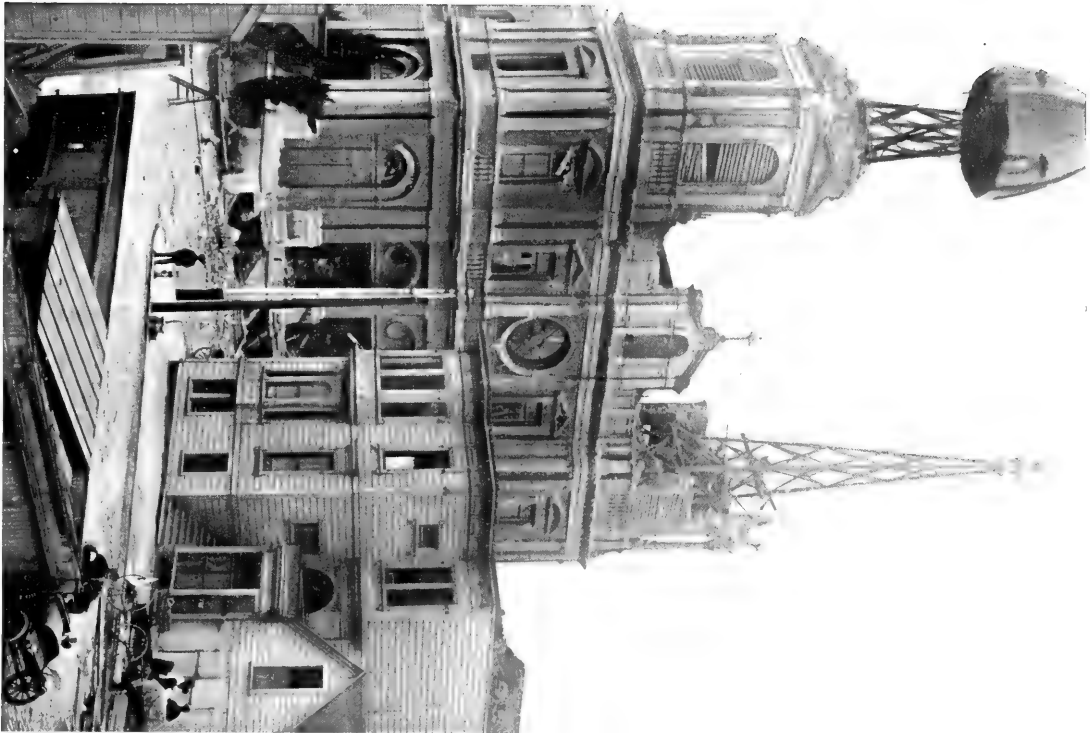
A. St. Dominic's Church, Bush and Steiner Streets, Brick and masonry structure upon sand and alluvium of no great depth. A. C. L.

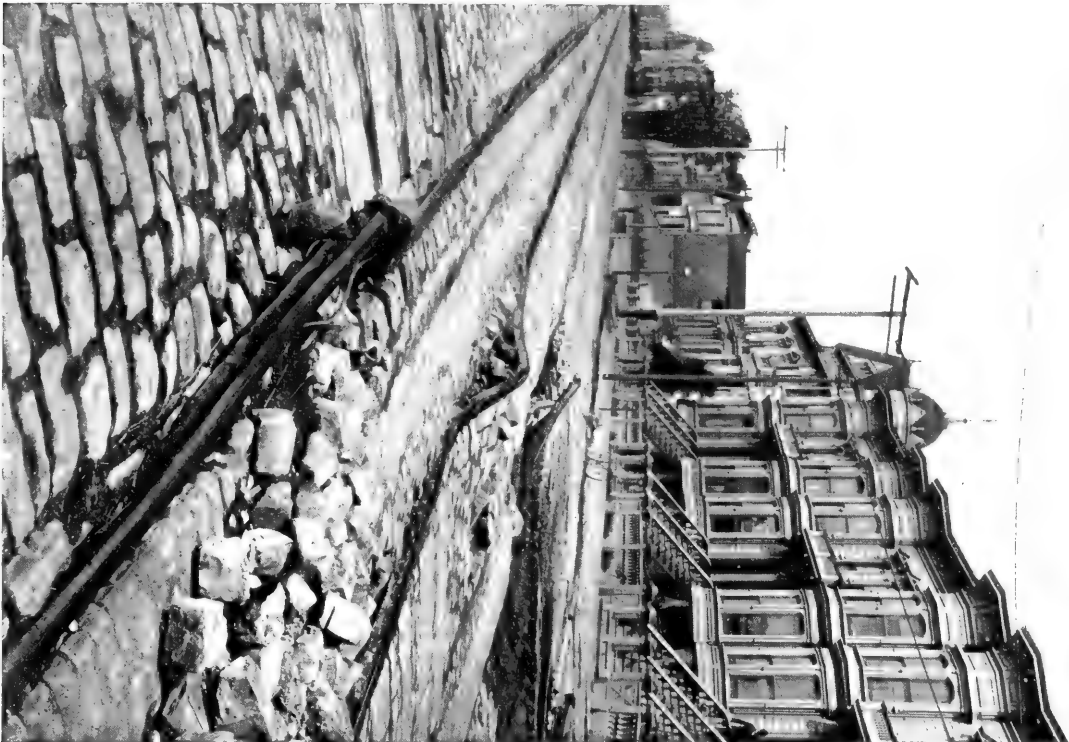
B. Looking south on Howard Street from near Seventeenth Street. Compression flexure of car rails. G. K. G.

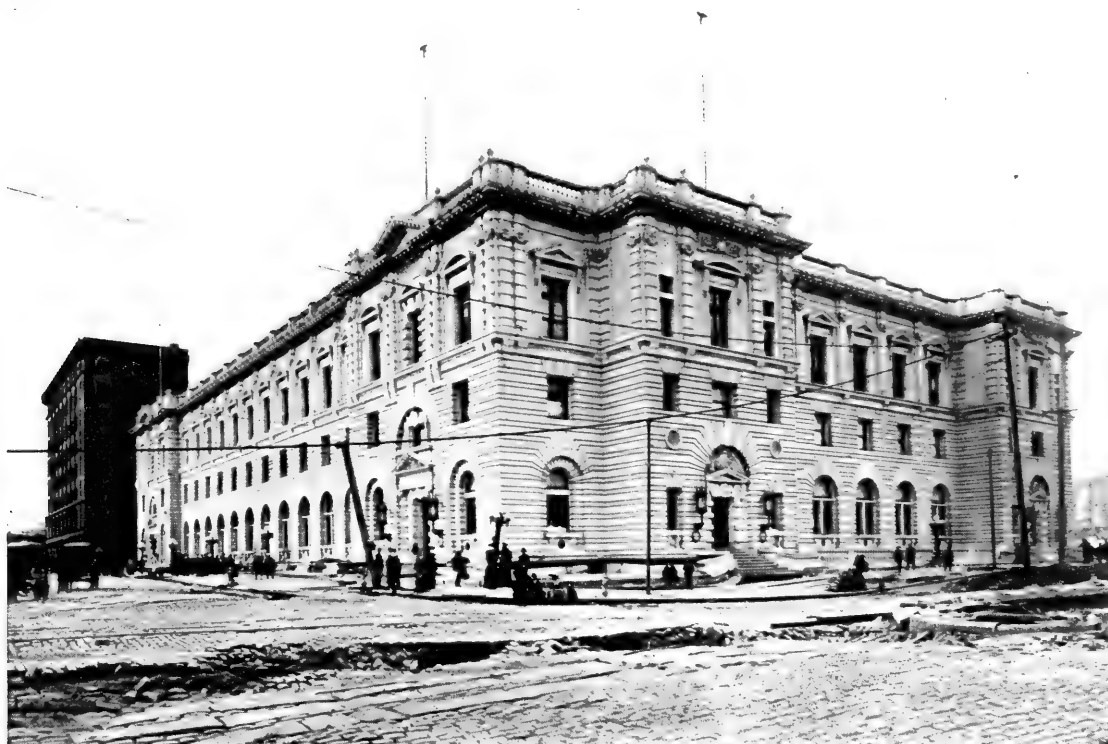
B. San Francisco Post-office, Mission and Seventh Streets. Near corner of building is on edge of old marsh. Ground over marsh sank and lurched. W. E. Worden, Photo.

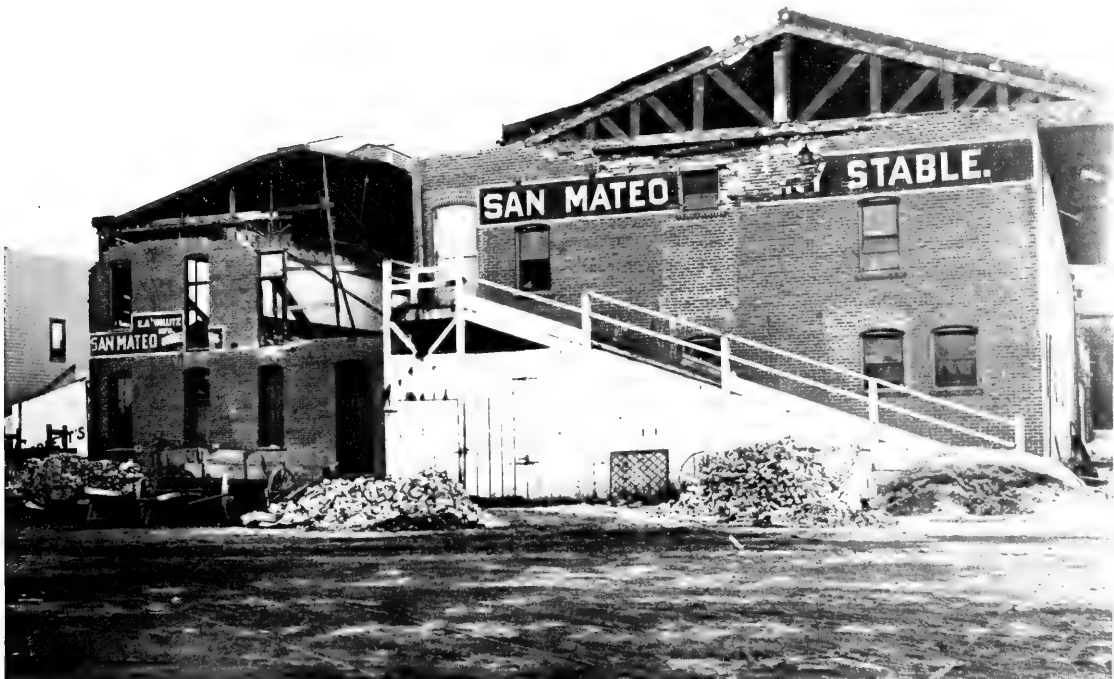
B. Brick stable, San Mateo. Upper story was thrown out and roof dropt one story. Per J. C. B.
